**AMCO ROTAVATOR, Model: AMCO RT 200 (Gear Drive)  
(Tractor Operated)**

**NORTH EASTERN REGION FARM MACHINERY TRAINING & TESTING INSTITUTE**

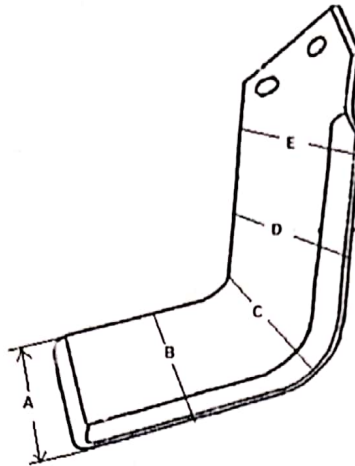
Fig 7 : DIMENSIONS FOR WEAR ANALYSIS

- 10.6 The hourly rate of wear of blade on mass basis in Dry & Wet land operations was recorded as 0.09 to 0.16 % and 0.03 to 0.16 % respectively. The average wear of blade is considered as on higher side.

- 10.7 The hourly rate of wear of blade on dimensional basis in Dry land & Wet land operations was recorded as 0.02 to 1.68 % and 0.04 to 0.38 % respectively. The average wear of blade is considered as on higher side.
