व्यावसायिक परीक्षण रिपोर्ट
COMMERCIAL TEST REPORT

संख्या / No.: Imp-224/297
माह / Month: December 2017

GREENSYSTEM ROTARY TILLER, Model: RT1005 (Chain Drive)
(Tractor Operated)

**NORTH EASTERN REGION FARM MACHINERY TRAINING & TESTING
INSTITUTE**

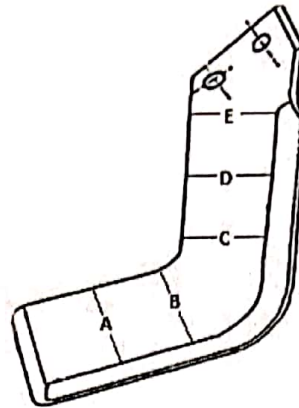
Fig 7 : DIMENSIONS FOR WEAR ANALYSIS

- 10.6 The hourly rate of wear of blade on mass basis in Dry land & Wet land operations was recorded as 0.11 to 0.12 % and 0.04 to 0.06 % respectively. The average wear of blade is considered as on higher side.

- 10.7 The hourly rate of wear of blade on dimensional basis in Dry land & Wet land operations was recorded as 0.01 to 0.32 % and as 0.01 to 0.04 % respectively. The average wear of blade is considered as on higher side.
