**LANDFORCE, ROTARY TILLER, Model: RNMMGHAMC  
(Gear Drive) (Tractor Operated)**

**NORTH EASTERN REGION FARM MACHINERY TRAINING & TESTING INSTITUTE**

Imp-227/300

LANDFORCE, ROTARY TILLER, Model : RNMMGHAMC (Gear Drive)  
(Tractor Operated) [Commercial]

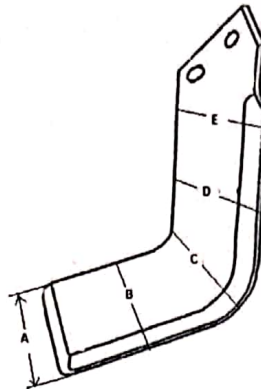
Fig 7 : DIMENSIONS FOR WEAR ANALYSIS

- 10.7 The hourly rate of wear of blade on mass basis in Dry & Wetland operations was recorded as 0.07 to 0.11 % and 0.04 to 0.05 % respectively.

- 10.8 The hourly rate of wear of blade on dimensional basis in Dry & Wet land operations was recorded as 0.01 to 0.35 % and as 0.01 to 0.14 % respectively.
- 10.9 Product, model, serial no. and year of manufacture are indicated on the labeling plate. However, it is recommended to specify size of implement and power requirement for the implement.
- 10.10 No ingress of mud and/or water was found in primary and secondary reduction boxes after 40.8 h of Dry and Wet land operations and the sealing provided on different subassemblies were found effective.
- 10.11 **Technical literature:**  
Operator's manual, Service manual and Parts Catalogue were provided along with the machine during the course of testing in English only. It is further recommended to bring out these manual in Hindi and other vernacular languages as per IS: 8132-1999.
