व्यावसायिक परीक्षण रिपोर्ट
COMMERCIAL TEST REPORT

संख्या / No.: Imp-228/301
माह / Month: February, 2018

**AMCO ROTAVATOR, Model: AMCO RT175 (Gear Drive)
(Tractor Operated)**

NORTH EASTERN REGION FARM MACHINERY TRAINING & TESTING INSTITUTE

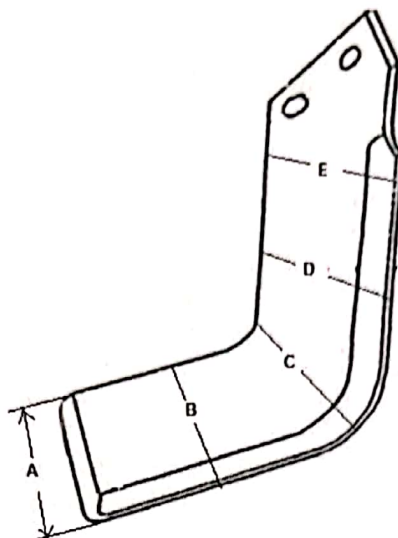
Fig 7 : DIMENSIONS FOR WEAR ANALYSIS

- 10.6 The hourly rate of wear of blade on mass basis in Dry & Wet land operations was recorded as 0.16 to 0.29 % and 0.02 to 0.05 % respectively.
- 10.7 The hourly rate of wear of blade on dimensional basis in Dry & Wet land operations was recorded as 0.00 to 0.86 % and as 0.01 to 0.24 % respectively.
