व्यावसायिक परीक्षण रिपोर्ट  
COMMERCIAL TEST REPORT

संख्या / No.: Imp-230/303  
माह / Month: March, 2018

**LANDFORCE, ROTARY TILLER, Model: RNMSGHEMB  
(Gear Drive) (Tractor Operated)**

**NORTH EASTERN REGION FARM MACHINERY TRAINING & TESTING INSTITUTE**

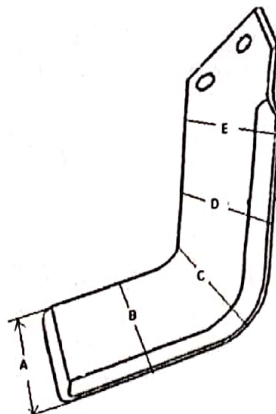
Fig 7 : DIMENSIONS FOR WEAR ANALYSIS

- 10.6 The hourly rate of wear of blade on mass basis in Dry land & Wetland operations was recorded as 0.41 to 0.50.% and 0.08 to 0.12.% respectively. The average wear of blade is considered as on higher side.

- 10.7 The hourly rate of wear of blade on dimensional basis in Dry land & Wet land operations was recorded as 0.02 to 1.60% and as 0.02 to 0.56% respectively. The average wear of blade is considered as on higher side.
