व्यावसायिक परीक्षण रिपोर्ट
COMMERCIAL TEST REPORT

संख्या / No. : Imp.143/192
माह / Month: October, 2013

SHAKTIMAN (SRT 5 /MS Light Series) Rotavator

NORTH EASTERN REGION FARM MACHINERY TRAINING & TESTING INSTITUTE

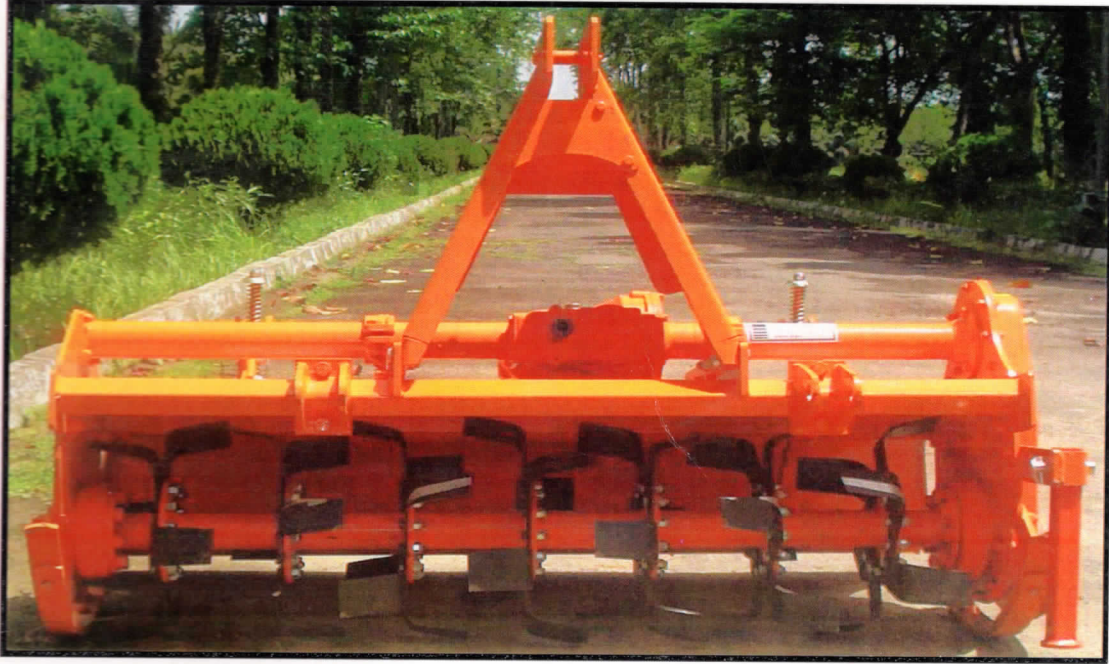
4.2 Constructional Details (Refer Fig.1):**KEYWORDS:**

| 1. Mainframe | 5. Primary reduction gear box |
| 2. Side plate width | 6. Secondary reduction gear box |
| 3. Rotor shaft | 7. Skid |
| 4. Rotor blade | 8. Hitch pyramid |
