व्यावसायिक परीक्षण रिपोर्ट (प्रारंभिक)
COMMERCIAL TEST REPORT (Initial)

संख्या/No.: Machine 153/527
माह / Month: March 2025

CLIF, GX 35K, BRUSH CUTTER

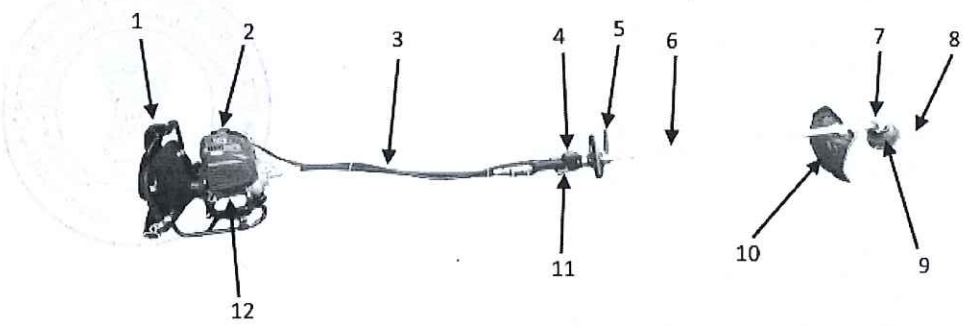
Fig. 1: CLIF, BRUSH CUTTER, MODEL: GX 35K
