व्यावसायिक परीक्षण रिपोर्ट
COMMERCIAL TEST REPORT

**GREENSYSTEM ROTARY TILLER, Model: RT1037 (Gear Drive)
(Tractor Operated)**

NORTH EASTERN REGION FARM MACHINERY TRAINING & TESTING INSTITUTE

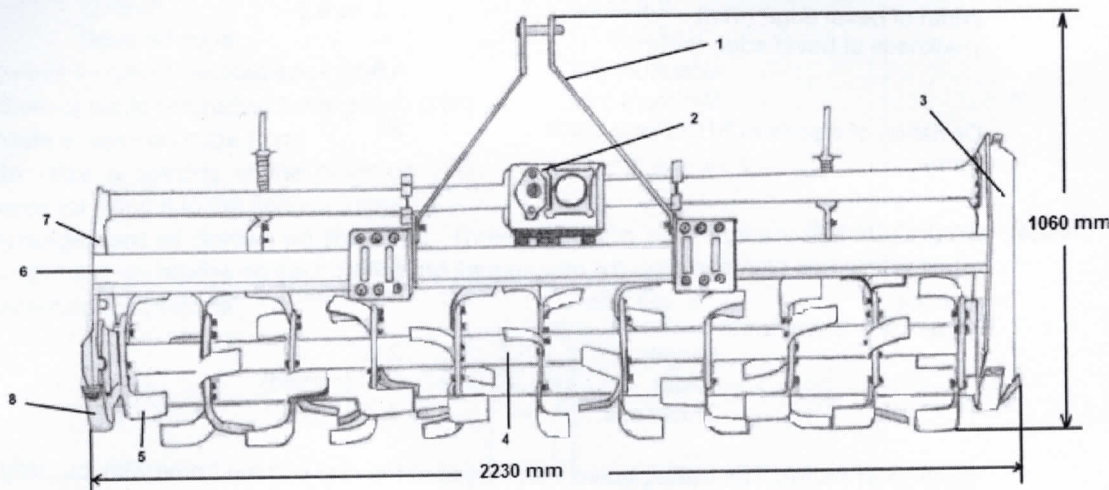
Fig.1: **SCHEMATIC VIEW OF GREENSYSTEM MODEL- RT1037, ROTAVATOR**

1. Hitch pyramid	5. Rotor blade
2. Primary reduction gear box	6. Main frame
3. Secondary reduction gear box	7. Side plate
4. Rotor shaft	8. Skid

4.2 Constructional Details (Refer Fig.1):
