**LANDFORCE, DCSS-9, SPRING LOADED NINE TYNE CULTIVATOR  
(Tractor Mounted)**

उत्तर पूर्वी क्षेत्र कृषि यंत्र प्रशिक्षण एवं परीक्षण संस्थान

## 1. SCOPE OF TEST

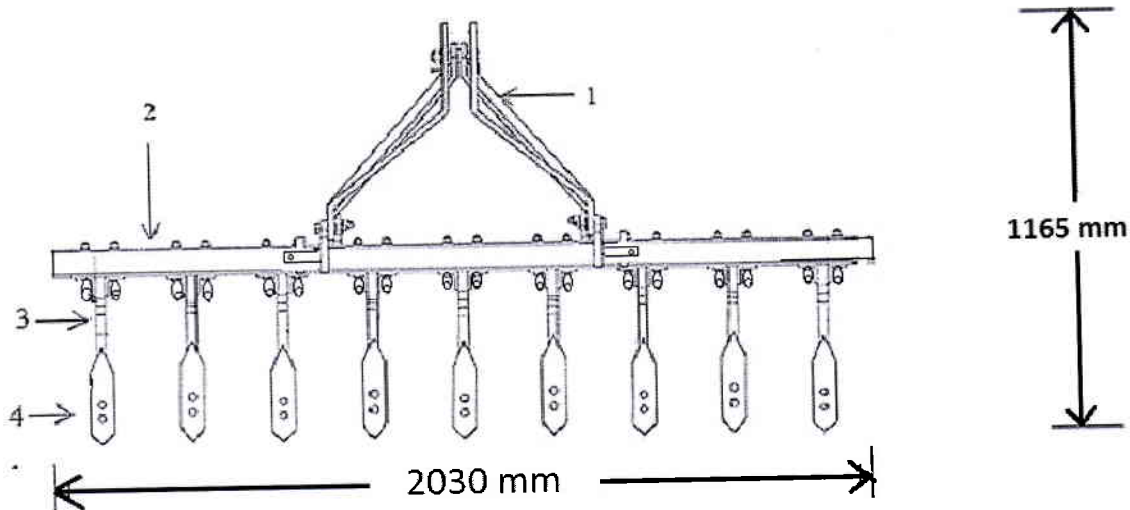
**Fig.1: LANDFORCE DCSS-9 SPRING LOADED NINE TYNE CULTIVATOR**

#### 4.2 Constructional Details (Refer Fig.1) :

| 1. Hitch pyramid | 3. Tyne |
