व्यावसायिक परीक्षण रिपोर्ट
COMMERCIAL TEST REPORT

संख्या / No.: Imp.194/264
माह / Month: December, 2016

**NEW SWAN ROTAVATOR, Model: NSML GT165 (Gear Drive)
(Tractor Operated)**

NORTH EASTERN REGION FARM MACHINERY TRAINING & TESTING INSTITUTE

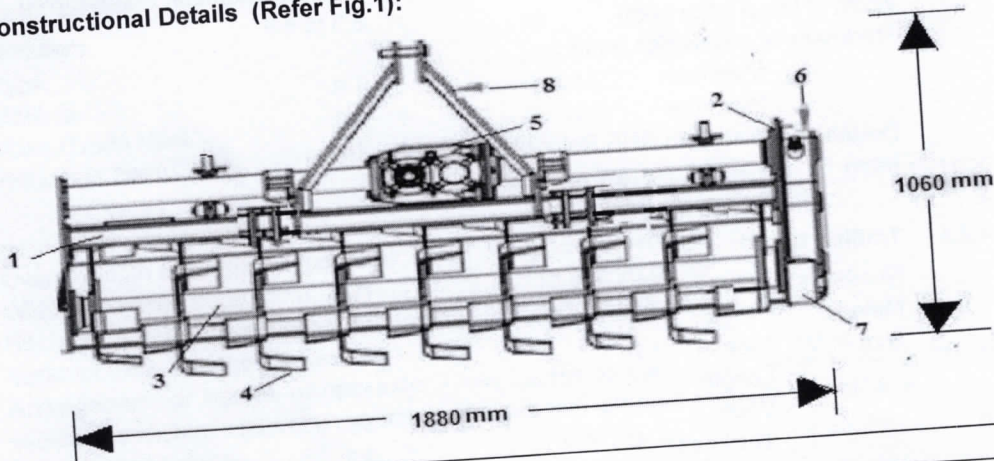
Fig.1: SCHEMATIC VIEW OF NEW SWAN NSML GT 165 ROTAVATOR

1.	Mainframe	5.	Primary reduction gear box
2.	Side plate	6.	Secondary reduction gear box
3.	Rotor shaft	7.	Skid
4.	Rotor blade	8.	Hitch pyramid

4.2 Constructional Details (Refer Fig.1):
