व्यावसायिक परीक्षण रिपोर्ट  
COMMERCIAL TEST REPORT

संख्या / No.: Imp.195/265  
माह / Month: December, 2016

**NEW SWAN ROTAVATOR, Model: NSML DT175 (Gear Drive)  
(Tractor Operated)**

**NORTH EASTERN REGION FARM MACHINERY TRAINING & TESTING INSTITUTE**

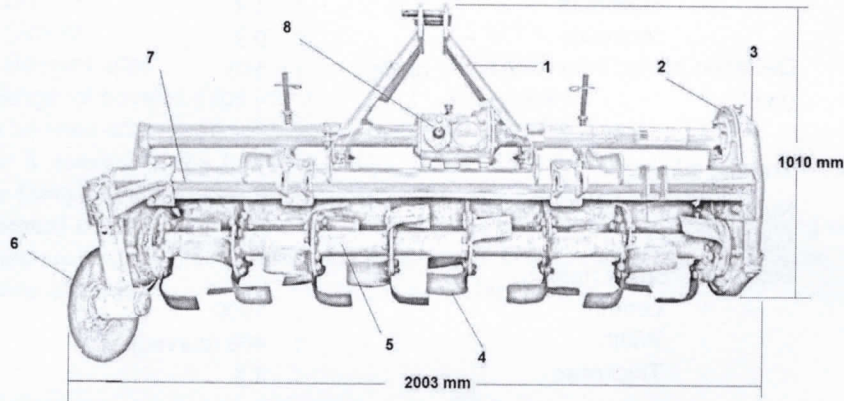
Fig.1: **SCHEMATIC VIEW OF NEW SWAN NSMLDT 175 ROTAVATOR**

#### 4.2 Constructional Details (Refer Fig.1):

1.	Hitch pyramid	5.	Rotor shaft
2.	Side plate	6.	Cutting Disc
3.	Secondary reduction gear box	7.	Mainframe
4.	Rotor blade	8.	Primary reduction gear box
