**NEW SWAN ROTAVATOR, Model: NSML GT 205 (Gear Drive)
(Tractor Operated)**

T R. No. 2898

NORTH EASTERN REGION FARM MACHINERY TRAINING & TESTING INSTITUTE

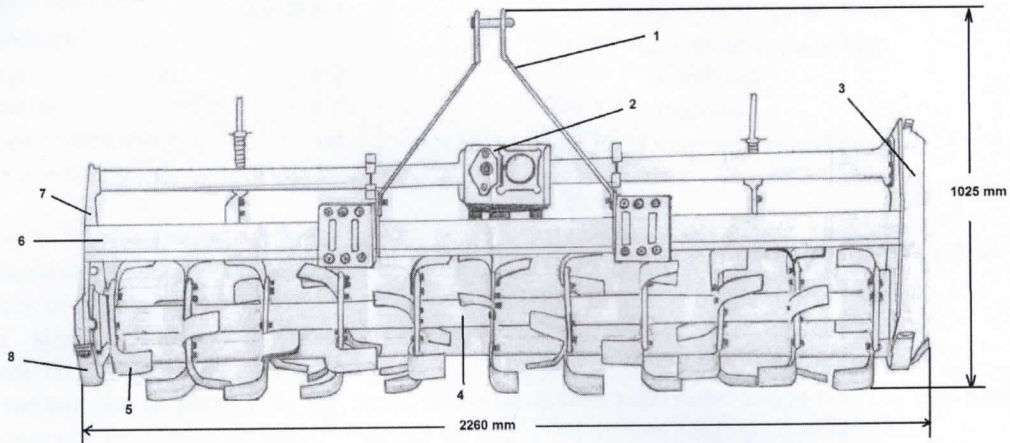
Fig.1: SCHEMATIC VIEW OF NEW SWAN GT 205 ROTAVATOR

4.2 Constructional Details (Refer Fig.1):

1.	Hitch pyramid	5.	Rotor blade
2.	Primary reduction gear box	6.	Mainframe
3.	Secondary reduction gear box	7.	Side plate
4.	Rotor shaft	8.	Skid
