व्यावसायिक परीक्षण रिपोर्ट COMMERCIAL TEST REPORT

संख्या / No.: Imp.207/279 माह / Month: February, 2017

NEW SWAN ROTAVATOR, Model: NSML DT150 (Gear Drive) (Tractor Operated)

NORTH EASTERN REGION FARM MACHINERY TRAINING & TESTING INSTITUTE

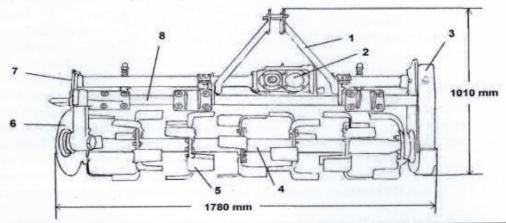
Fig.1: SCHEMATIC VIEW OF NEW SWAN NSML DT 150 ROTAVATOR

KEY	WORDS:			
1.	Hitch pyramid	5.	Rotor blade	
2.	Primary reduction gear box	6.	Cutting Disc	
3.	Secondary reduction gear box	7.	Side plate	
4.	Rotor shaft	8.	Mainframe

Constructional Details: It consisted of a square MS pipe of size 1620 x 50.7 x 50.7 mm welded with two nos. of cross member (MS plate) each of size 550 x 110 x 8.5 mm in RHS and LHS respectively. One MS sheet is welded over the rotor unit on the frame (top cover) of size 1620 x 460 (curved) x 3.0 mm. One MS hollow pipe of size $583 \times 76.7 \Phi$ mm was fitted to the LHS plate extending from the LHS of the primary reduction gear box. In the RHS of primary reduction gear box one more MS hollow pipe of size $770 \times 76.7 \Phi$ mm was welded and extended up to the RHS side plate.
